# Case Study Title: South Corridor bridge strengthening in Panama City,

**Location:** Panama

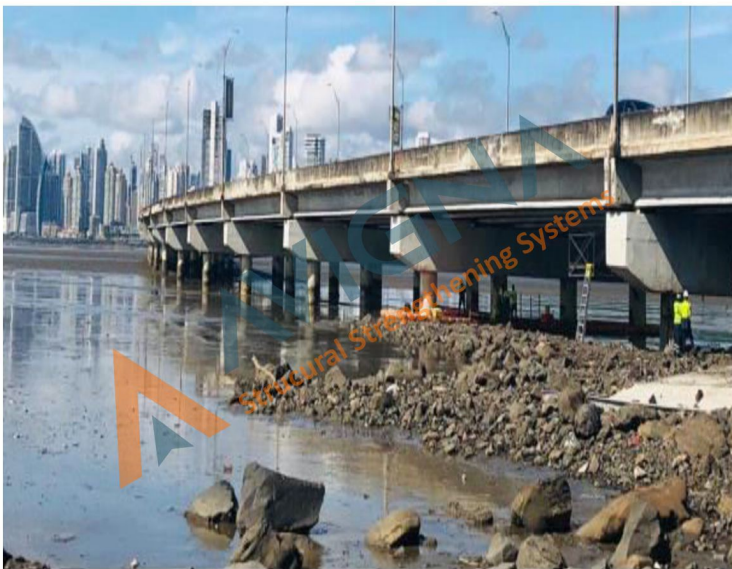
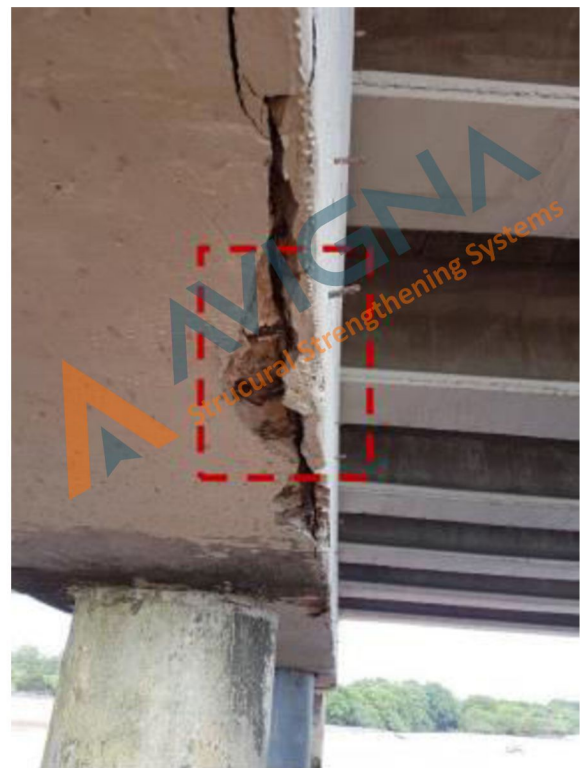
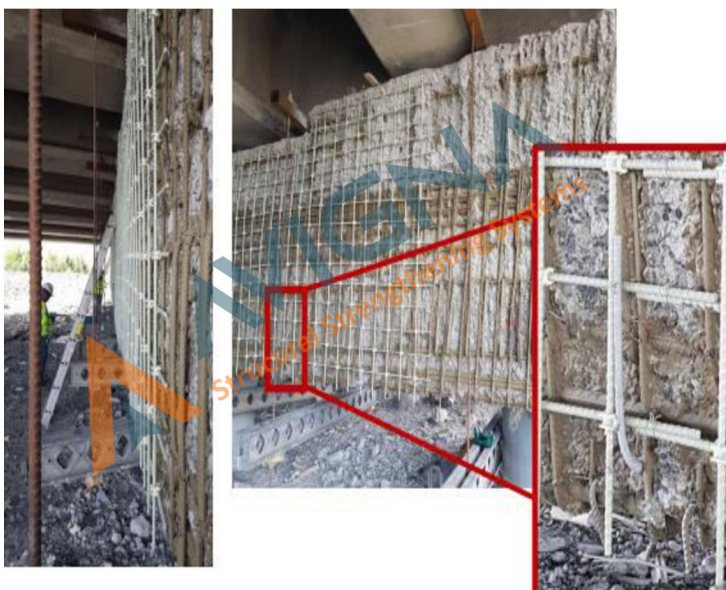
**General assessment:** The bent caps are 5-feet deep and 5-feet wide. The highway includes 6 lanes across. Each bent cap is supported by four columns, 48 inches in diameter and exposed between 6 and 15 ft above the seabed

**Problem:** south corridor is exhibiting signs of corrosion in columns, bent caps and girders

**Solution:** the columns and the bent caps, where GFRP reinforcement was used.
