Strengthening of the Frame Structure with carbon fiber wrapp at the Timisoreana Brewery, Romania

Location: Romania

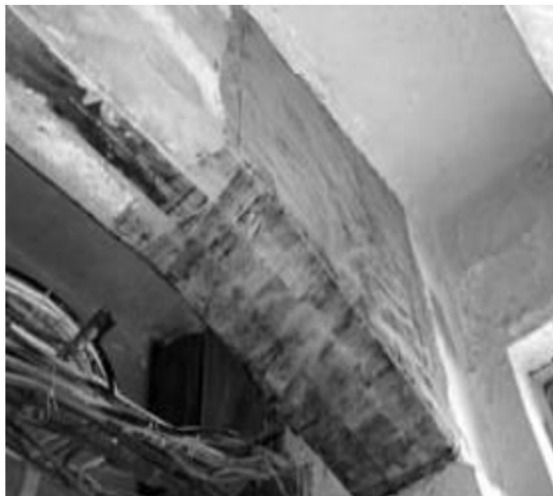
Beam wrapping

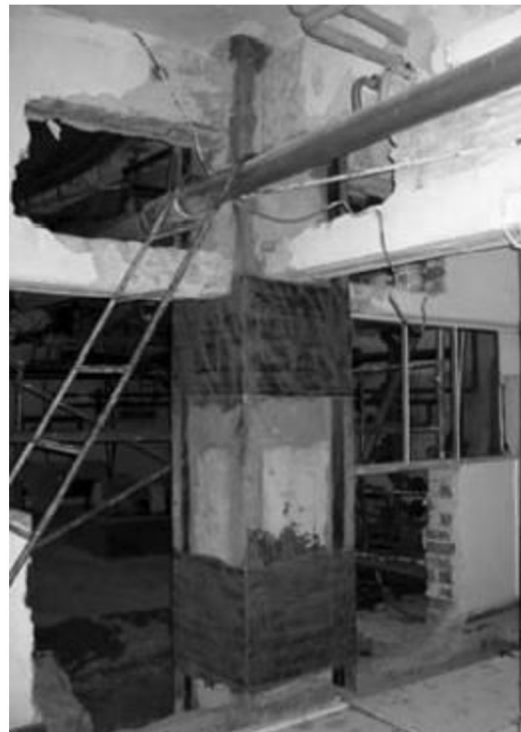
column wrapping

The column was strengthened at the ground storey by longitudinal carbon fibre polymer composites (CFRP) as on each side of 100 mm width and 1.2 mm thickness. (230 GSM)
