# Strengthening of masonry walls in an office building, Zurich, Switzerland

**Location:** Zurich, Switzerland

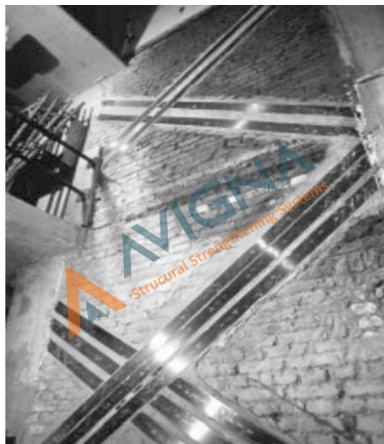
**Problem:** Amongst many other alterations, old wooden floors and all of the inner load bearing walls and one entire façade had to be removed and replaced by reinforced concrete slabs and columns. Only parts of the interior unreinforced masonry (URM) fire wall remained in place. These alterations changed both the stiffness and the load bearing capacity of the whole structure.

**Solution:** The strengthening system was utilised on one side of the wall for three storeys using 100mm wide strips, 1.2mm in thickness laid diagonally across the wall.
