Strengthening with Prestressed CFRP Strips of Box Girders on the Chofu Bridge, Japan

Location: located in the western part of Tokyo, Japan

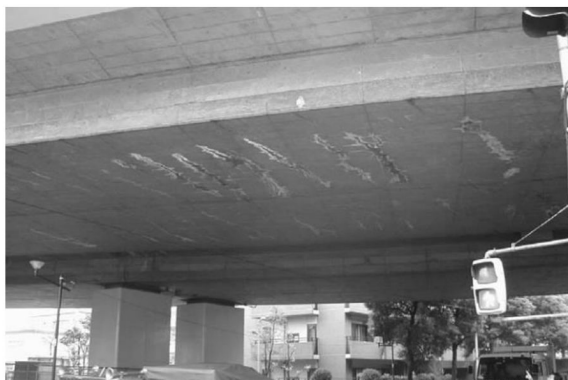
Problem: In the Chofu Bridge, which is an RC box girder bridge, many cracks had formed and water leakage from the cracks was observed at several locations. The deflection of the main girders caused by increase in heavy traffic and decrease in stiffness of the bridge.

Before

Solution: Steel plate bonding method and carbon fibre sheet bonding method were considered for this bridge. The CFRP strip is 2 mm thick and 50 mm wide. Each end of the strip is inserted into an anchoring device that is made of steel. Both ends are embedded and anchored by an expansive plate.

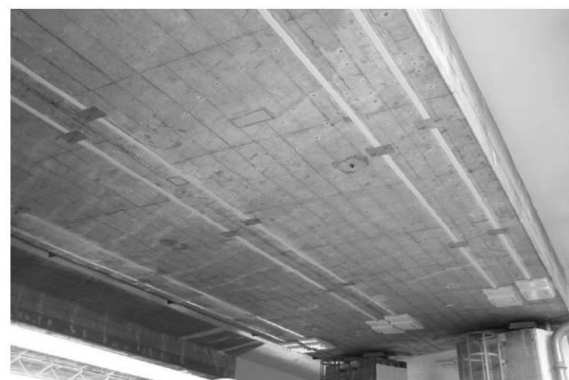
After
