# Strengthening with CFRP Strips of Dahanukar Wadi Box Culvert.

**Location:** Kandivali

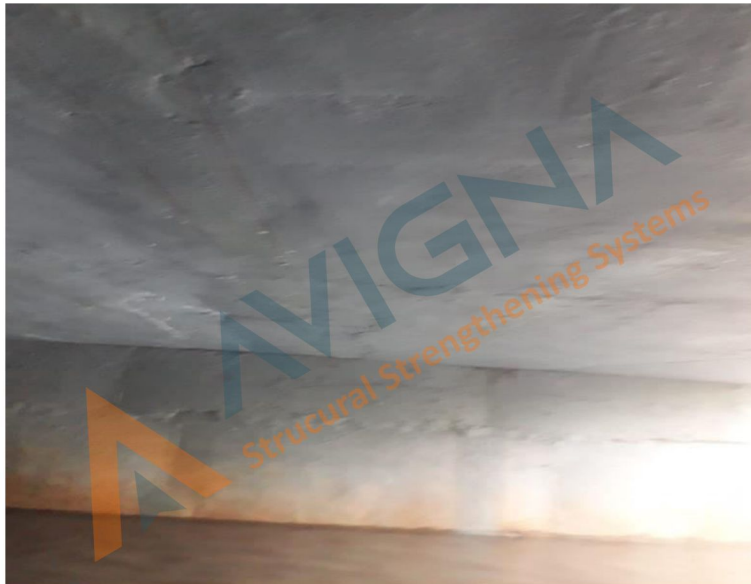
Before

**Problem:** In the Dahanukar Wadi Bridge, which is an RC box Culvert, many cracks had formed was observed at several locations. Honeycombing at the bottom slab was observed.
