Strengthening with CFRP Strips of Ramchandra Lane Box Culvert.

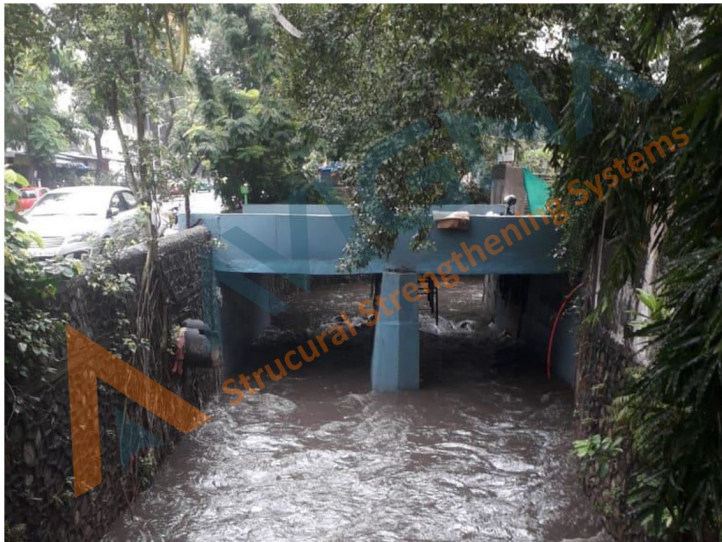
Before

Problem: In the Ramchandra Lane Bridge, which is an RC box Culvert, many cracks had formed was observed at several locations. Honeycombing at the bottom slab was observed.

Solution carbon fibre sheet bonding method (CFRP Laminates) were considered for this bridge. Each end of the strip is inserted into an anchoring device that is made of steel. Both ends are embedded and anchored by an expansive plate
