Strengthening with CFRP Strips of Sane Guruji Box Culvert.

Location: Mulund East

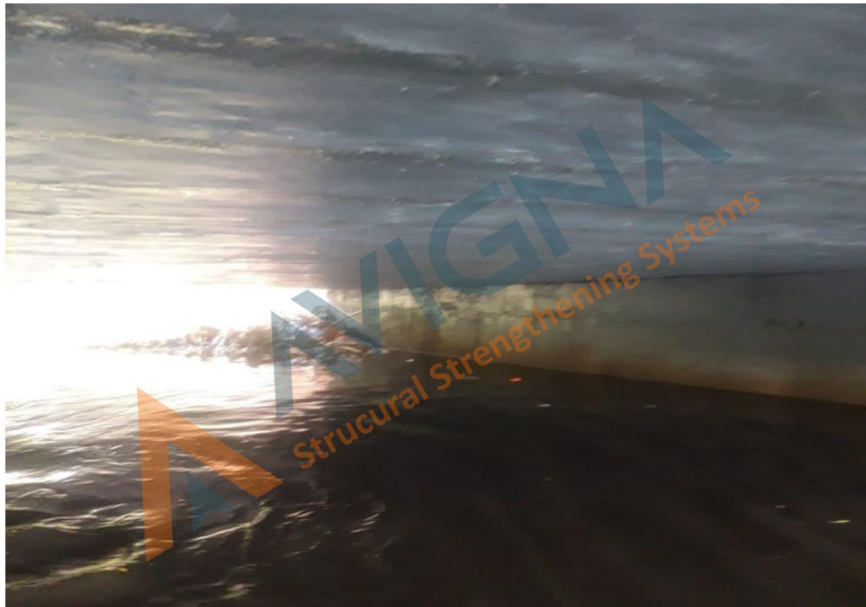
Before

Problem: In the Sane guruji Bridge, which is an RC box Culvert, many cracks had formed was observed at several locations. Honeycombing at the bottom slab was observed.
