Strengthening with CFRP Wrapping of Column at Building No 22.

Location: Vikhroli

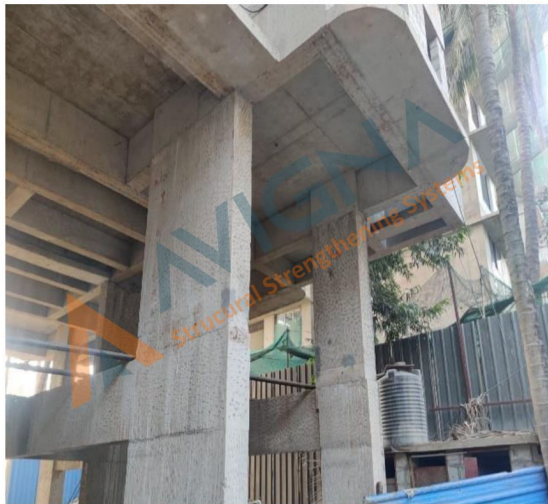
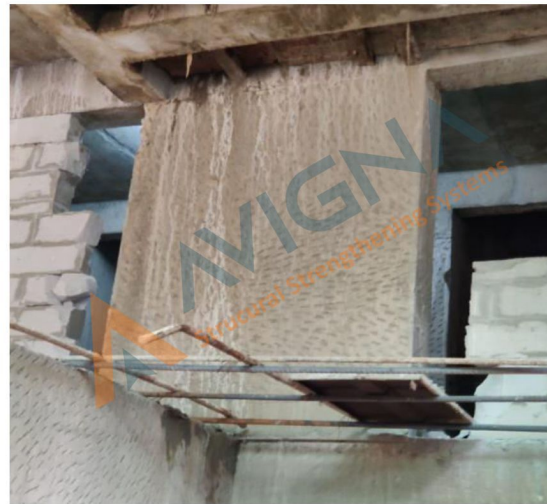
Problem: In the Building No:22, which is an RCC residential Building. In this building, Column having very low strength. For enhance the strength carbon fiber wrapping is suggested.

Before

Solution carbon fibre Wrapping System were considered for this building project.

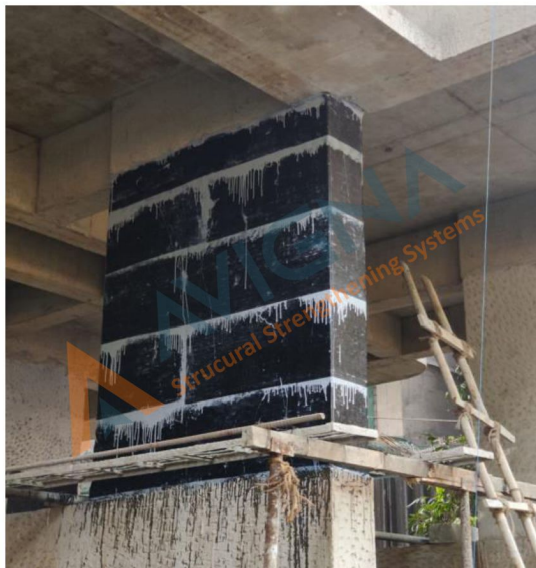
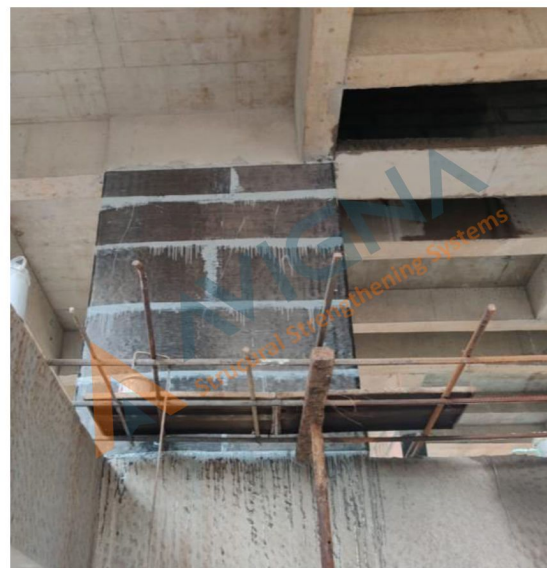
After
